Manhole Inspection Summary

Manhole # S13II1009MH

Insp Date: **3/12/07 9:40 AM**

Location Address: **4421 PALL MALL RD**

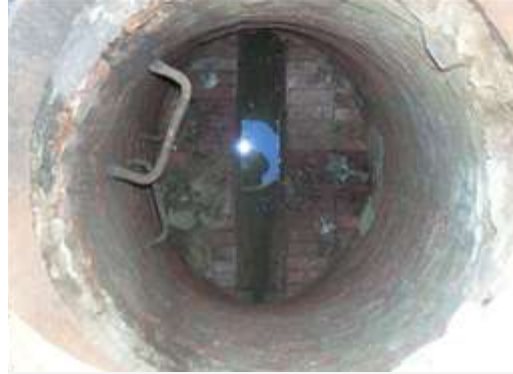
Top View

Evidence of surcharge - Bench debris.
Corroded steps.

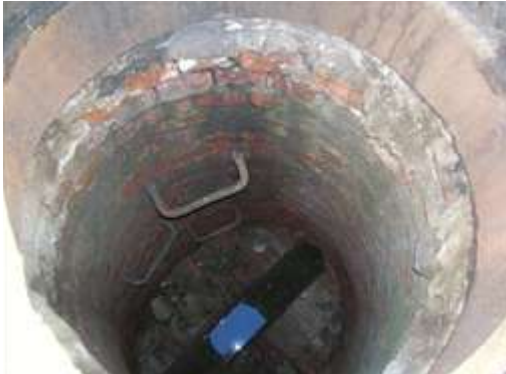
Defect

Adjustment deterioration and infiltration.
Corbel infiltration - other side.

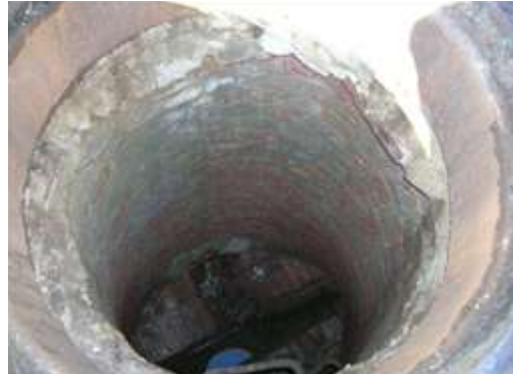
Defect

Adjustment deterioration and infiltration.
Corbel infiltration.

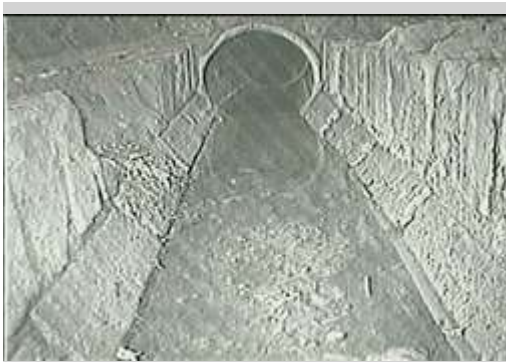
Defect

Channel deterioration and debris.

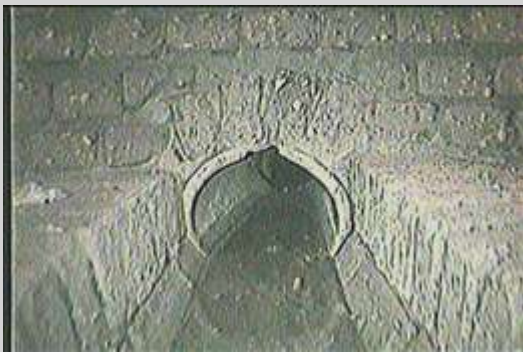
8 in. Circular Gravity Sewer Pipe Out @ 12 O'Clock

Deposits: ☐ None ☒ **Mud** ☐ Sludge ☒ **Debris** ☐ Grease

Silt Depth: **1** (in.) Deposits Extent: **Light**

Infiltration: **None** Pipe Seal Cond: **Cracked**

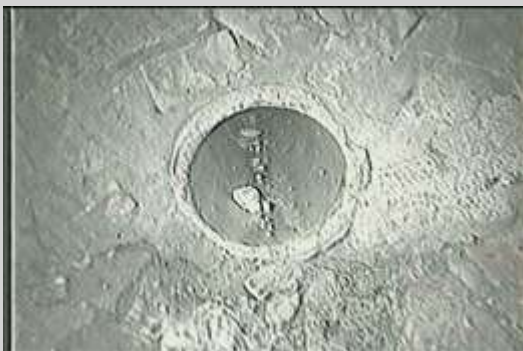
6 in. Circular Gravity Sewer Pipe In @ 3 O'Clock

Deposits: ☐ None ☐ **Mud** ☐ Sludge ☒ **Debris** ☐ Grease

Silt Depth: **0** (in.) Deposits Extent: **Light**

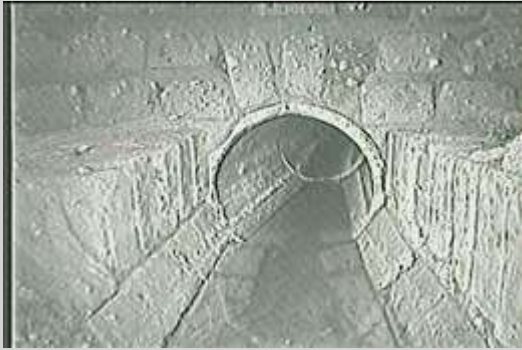
8 in. Circular Gravity Sewer

Deposits: ☐ None ☒ **Mud** ☐ Sludge ☒ **Debris** ☒ **Grease**

Silt Depth: **0.5** (in.)

Deposits Extent: **Light**
